MERRIMACK RIVER BASIN
TILTON, NEW HAMPSHIRE

TILTON TOWN DAM
NH 00151

PHASE I INSPECTION REPORT
NATIONAL DAM INSPECTION PROGRAM

JULY 1979

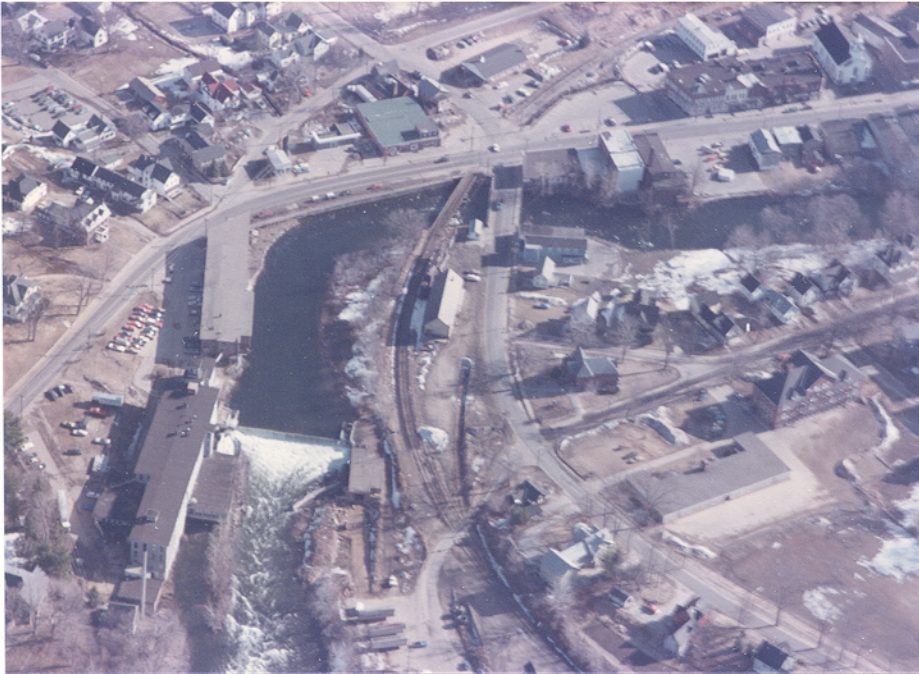
APRIL 1979
Figure 1 - Overview of Tilton Town Dam.

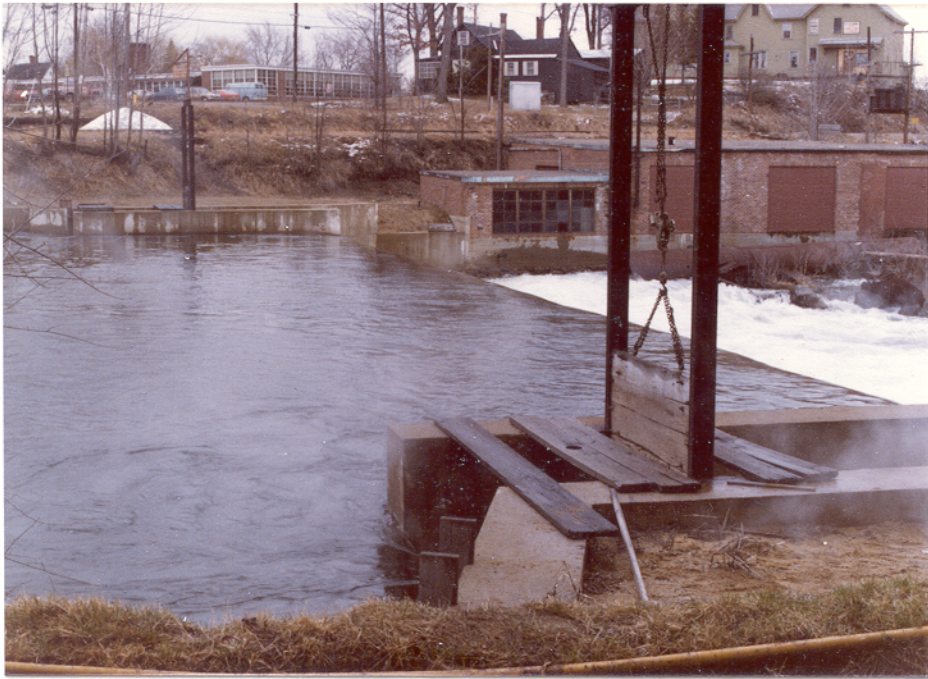
Figure 2 - Looking south across the upstream face of the dam from the north abutment.

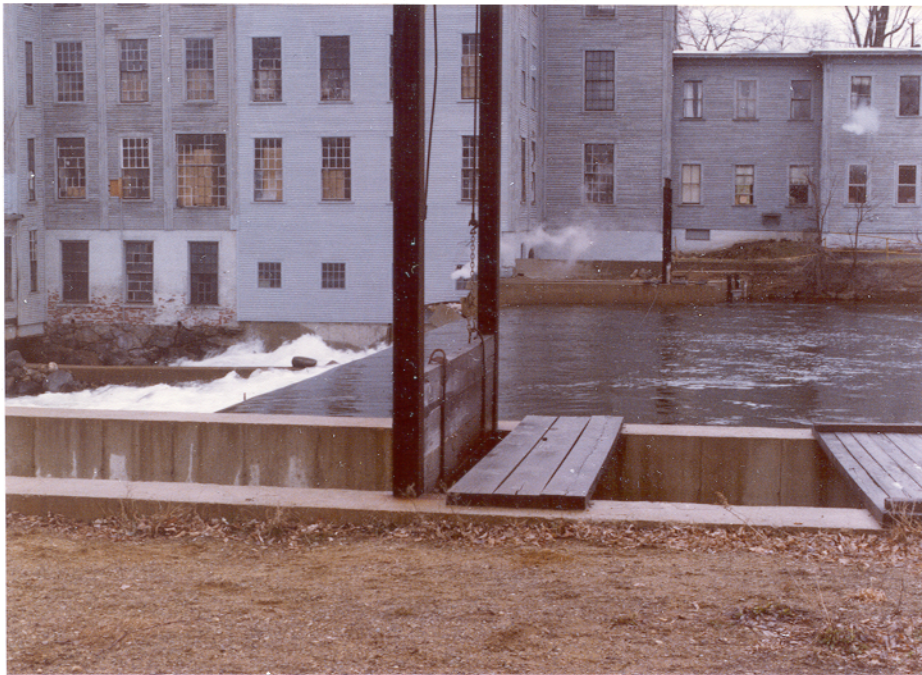
Figure 3 - Looking north across the upstream face of the dam from the south abutment.

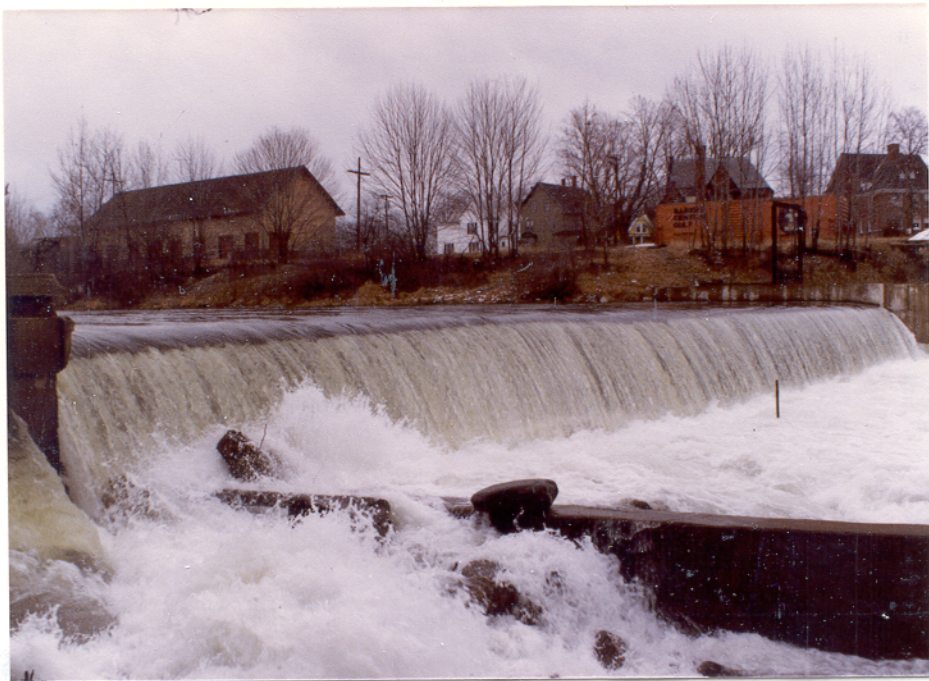
During the initial inspection performed April 6, 1979, about one foot of water was flowing over the crest of the spillway. It was noted that the level of the water flowing over the crest was not uniform along the length of the spillway. (See Appendix C - Figure 4.) From this observation it was inferred that local failures have occurred along the length of the structure. A subsequent inspection was performed April 24, 1979, in conjunction with representatives of the New Hampshire Water Resources Board (NHWRB) and the owner, the Town of Tilton. The NHWRB restricted discharge at Lakeport Dam, reducing flow in the Winnepesaukee River. The Town of Tilton opened both gates at Tilton Town Dam and the impoundment behind the dam was lowered so that little water was discharging over the crest of the dam. This enabled a more thorough inspection on the structural condition of the dam.

d. Visual Observations. The dam is in poor condition. The timber spillway has an uneven crest caused by some local support failures. The timber decking on the upstream face is in very poor condition.

Figure 4 - View of the spillway. Note the uneven level of the water.

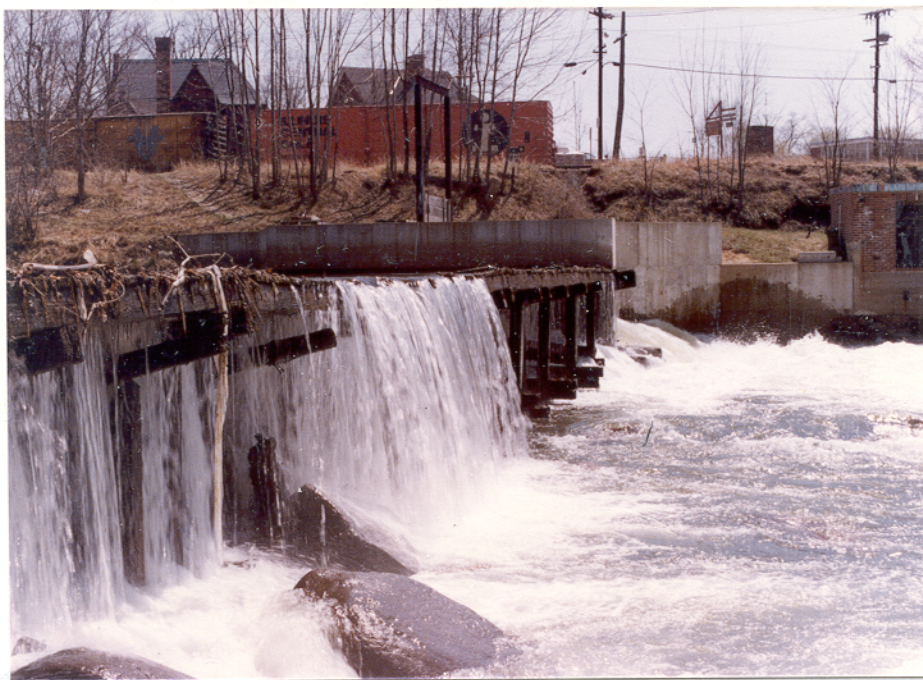
The timber frame of the dam is, in part, in poor condition and badly deteriorated. Confirmation of some local support failures was made. (See Appendix C - Figure 5.) The timber decking over the upstream face is in very poor condition. (See Appendix C - Figure 6.) Major quantities of water are pouring through large holes in the decking and lesser quantities through leaks along the entire length of the spillway. (See Appendix C - Figure 5.) Near the south abutment is a hole several feet in diameter in the decking and a whirlpool several feet in diameter was observed over this hole. (See Appendix C - Figure 7.)

Figure 5 - Looking at the spillway where local support failures have occurred. Note the water discharging through the spillway through holes in planking.

The owner should engage a registered professional engineer to design and supervise appropriate repairs to the sinkhole over supply pipe in south abutment and to the existing structure such as frame, decks, gates, lift mechanisms, etc. Attention should be paid to the possibility that the silt collected behind the dam may contain pollutants which could affect the downstream reaches of the river.

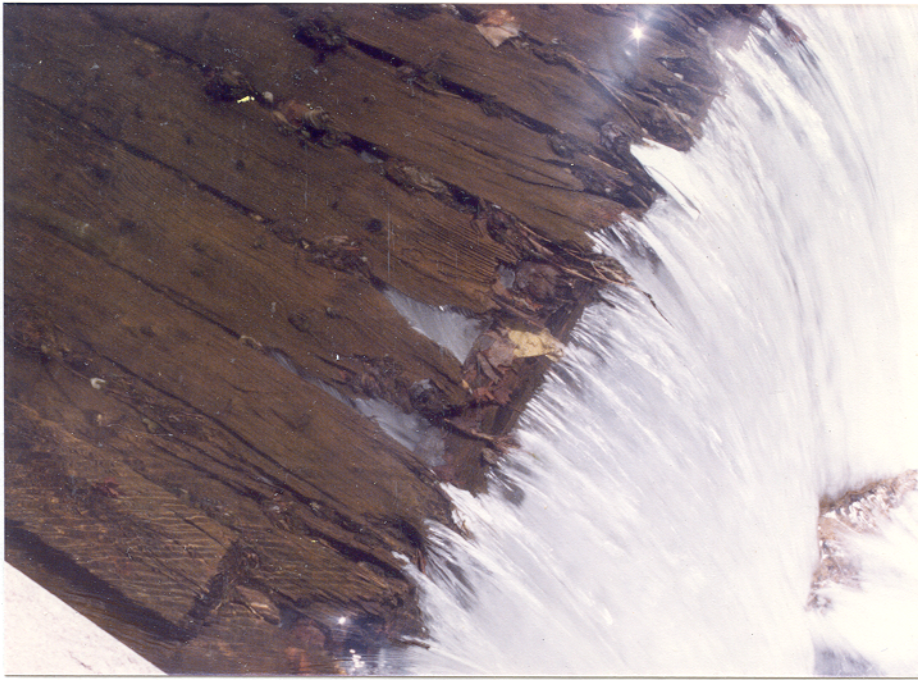
a. Visual Observations. The timber decking on the upstream face of the dam is in very poor condition. Large quantities of water are leaking through holes in the decking at many locations. Near the south abutment there is a hole several feet in diameter in the decking and there is a whirlpool several feet in diameter over the hole. The timber frame of the dam is also in poor condition.

Figure 6 - Closeup of the deteriorated planking
on the upstream side of the spillway.

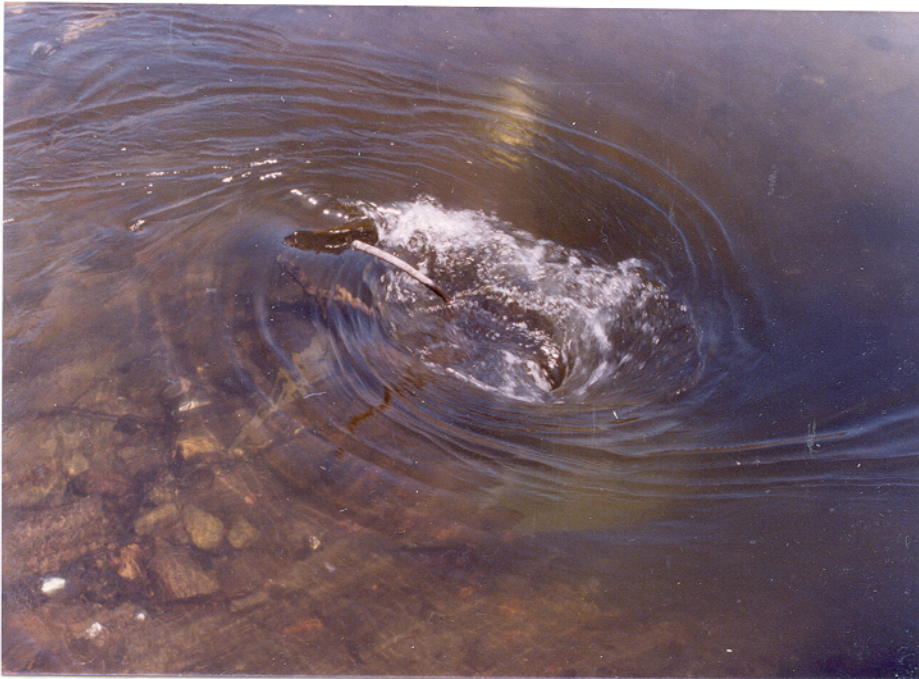
Figure 7 - View of the whirlpool located over a
hole in the planking.

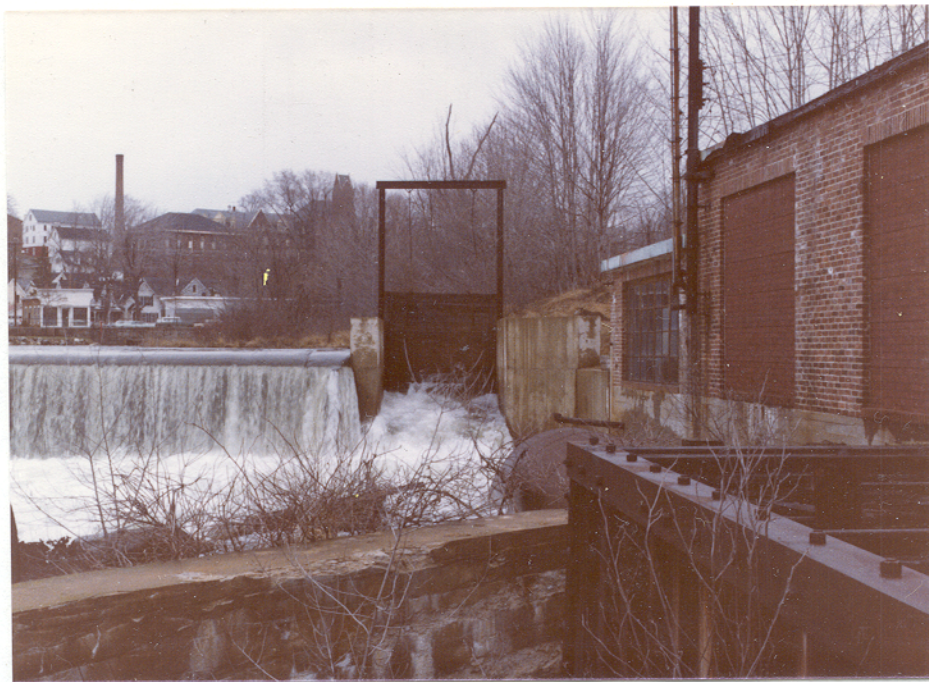
Figure 8 - View of the downstream face of the south abutment.

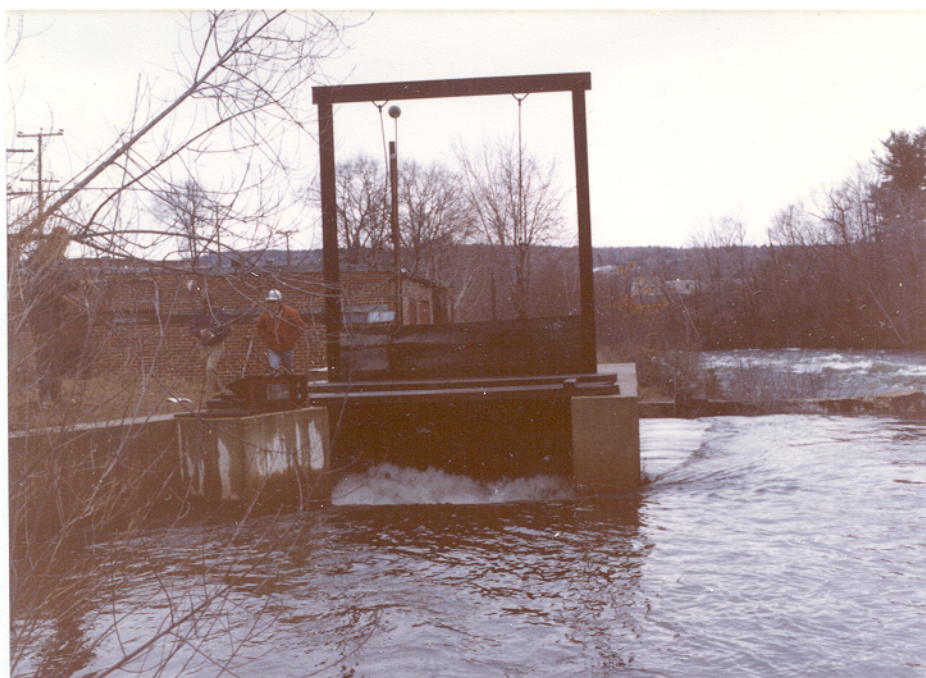
Figure 9 - View of the upstream face of the south abutment. Note the concrete box inlet structure.

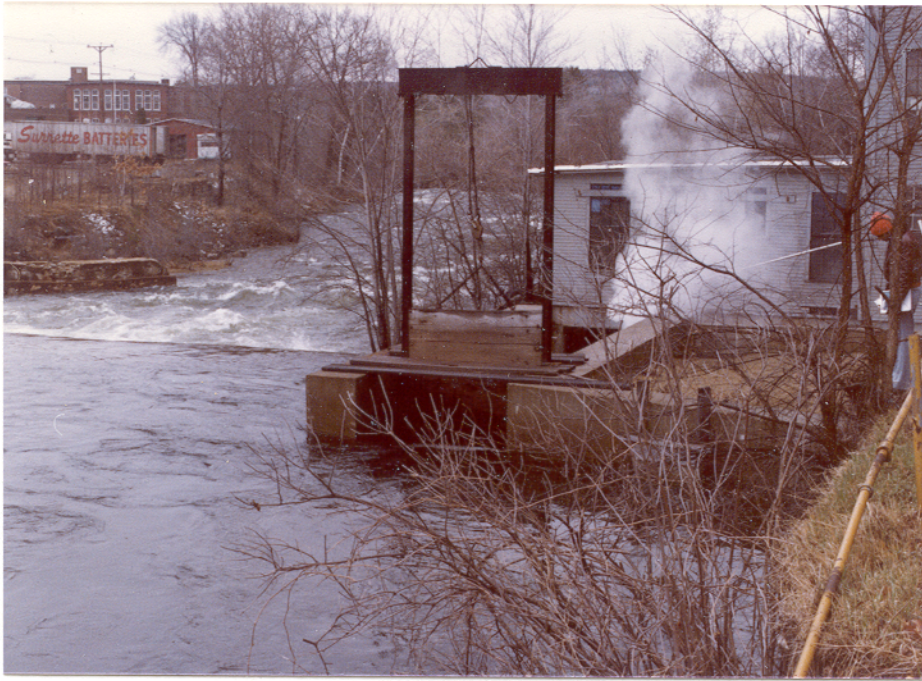
Figure 10 - Looking at the upstream face of the north abutment.

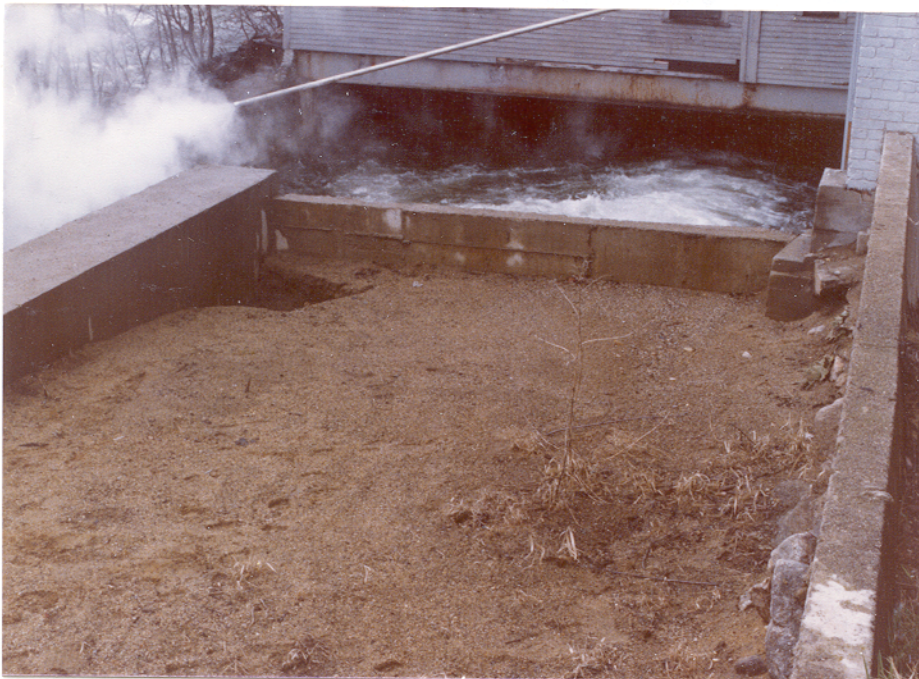
A sand fill has been placed between the north abutment and the sluiceway structure at the north end of the dam. A sinkhole, about 18 inches in diameter, was observed at the downstream side of this fill. (See Appendix C - Figure 11.) According to the maintenance manager of the Arthur S. Brown Mfg. Co., the sand fill was placed on top of a wood decking which, in turn, is above the water intake pipe to the mill. Collapse of the decking may have caused the sinkhole.

Figure 11 - View of the sinkhole observed in the fill at the north abutment.

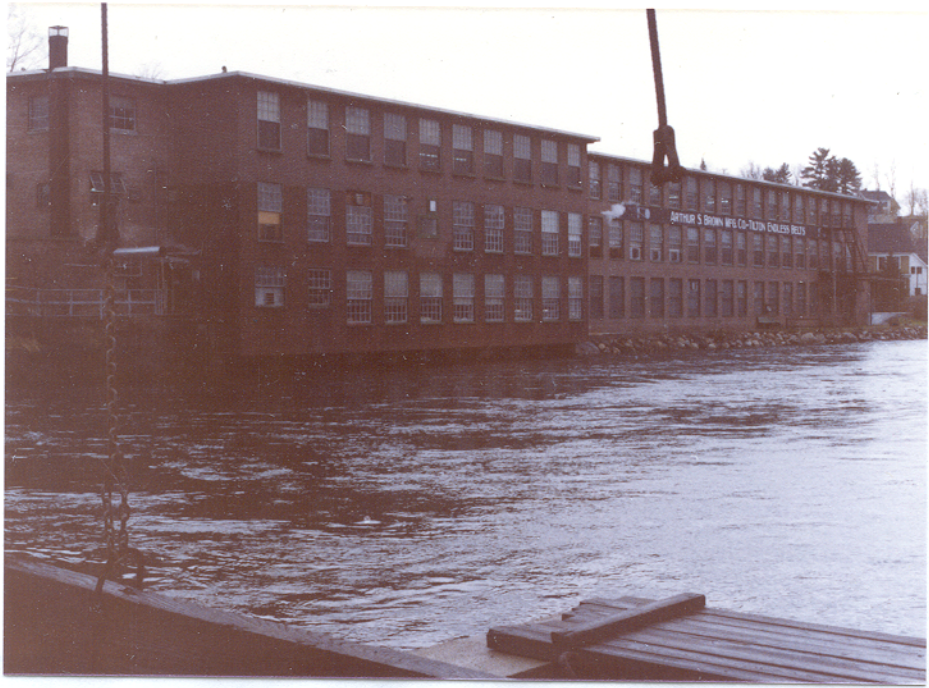
April 6, 1979
 Figure 12 - Looking upstream at the north approach channel from the south abutment.

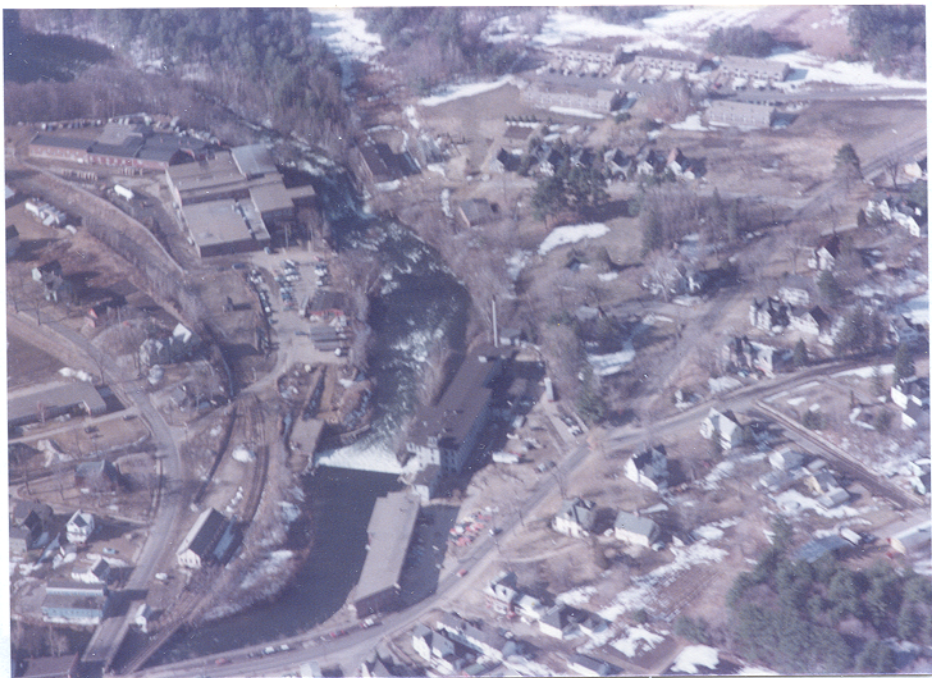
April 1979
 Figure 13 - Overview of the downstream channel.
